# FARM BUILDING PANELS

A Research Report on Developing and Evaluating  
An Insulated Concrete Stressed-Skin Panel

## A Research Report on Developing and Evaluating an Insulated Concrete Stressed-Skin Panel<sup>1</sup>

By T. E. Kent, N. C. Teter, and R. C. Liu<sup>2</sup>

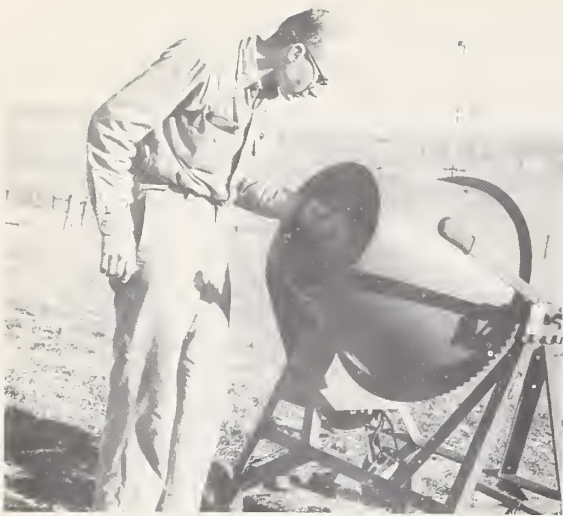
Cement mortar--one part cement to three parts well-graded sand--was mixed mechanically in a rotary mixer. Sufficient water, 7 gallons per bag of cement, was added to make a stiff grout.

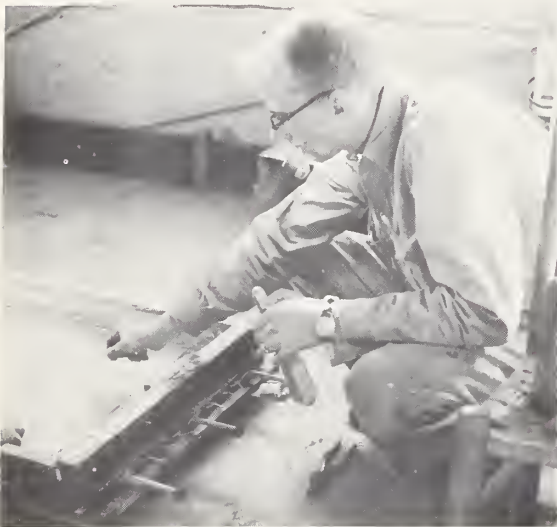
Reinforcing wire was prestretched prior to casting mortar. This stretching force held the wire within the one-half inch mortar. The release of the wire after partial curing relieved curing tensile stresses, which resulted in a thin mortar section with unusual strength properties.

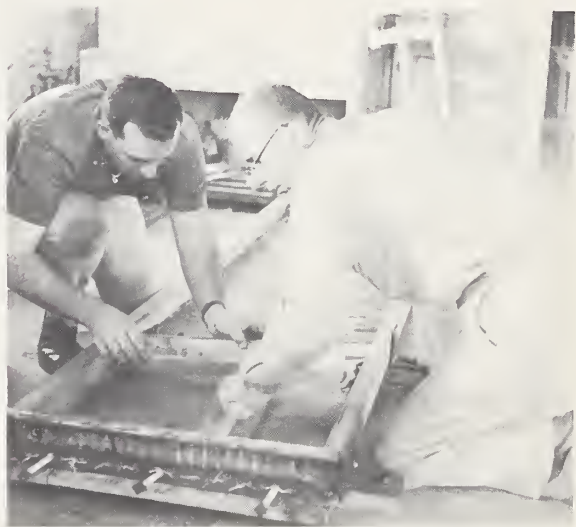
Mixed mortar was placed in the form. A screed and trowel were used to obtain the necessary dimensional accuracy.

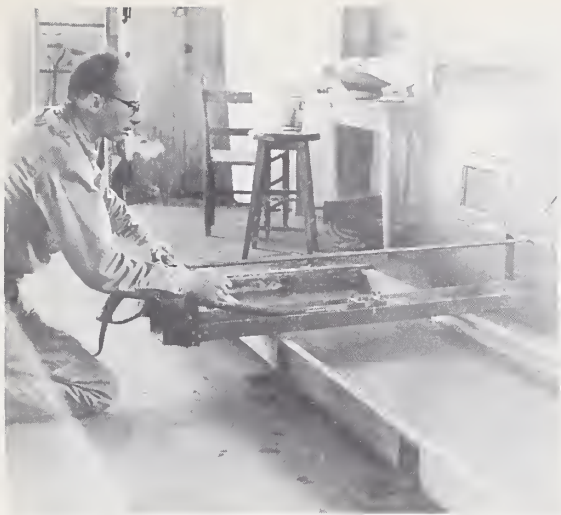
Vibration of the lower panel surface resulted in a very smooth surface with few air bubble voids. Panels were cast both with vibration and without vibration. By exercising care, smooth surfaces were obtained without vibration.

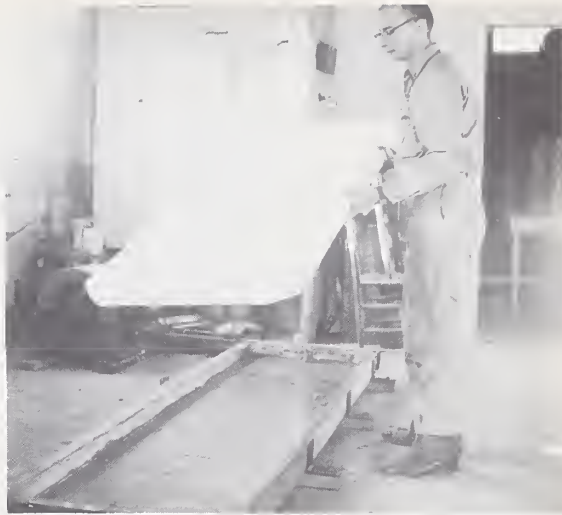
A precut core of expanded polystyrene placed above the lower panel surface had twelve 1-inch holes cut through to permit casting mortar shear resisters at strategic locations. Each corner of the core was rounded to permit these corners to fill with mortar to reduce panel handling damage.

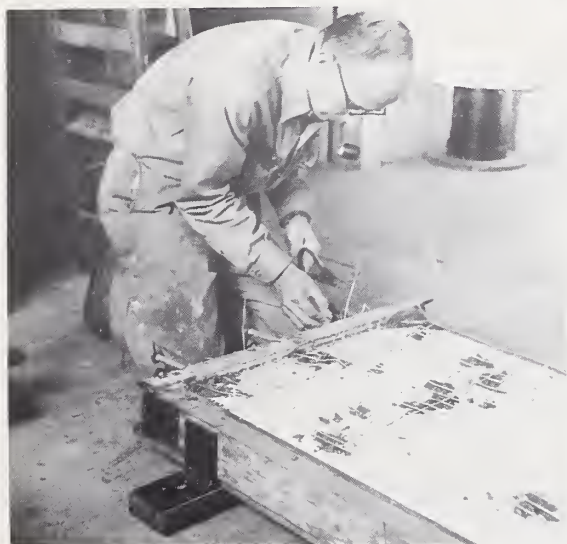
Welded wire reinforcing was then stretched for the top or outside surface of the panel. Each shear resister was also reinforced. (Note the 1/2" x 3" pipe cast in each end of the panel. These are useful for erection.)

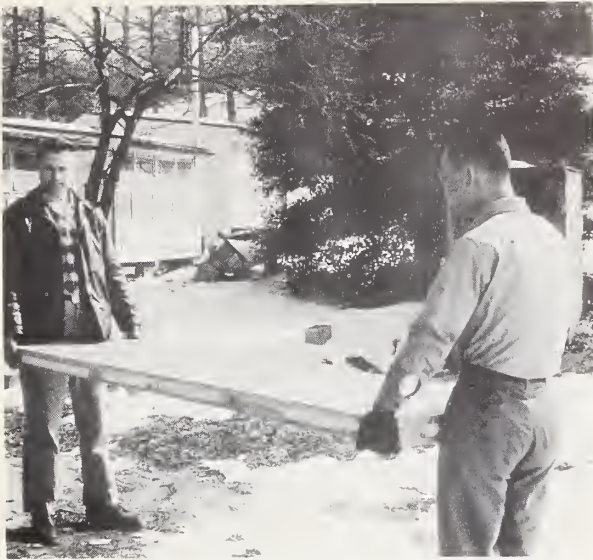
One of the objectives was the development of a panel light enough to be erected by two men. This panel weighs about 200 pounds.

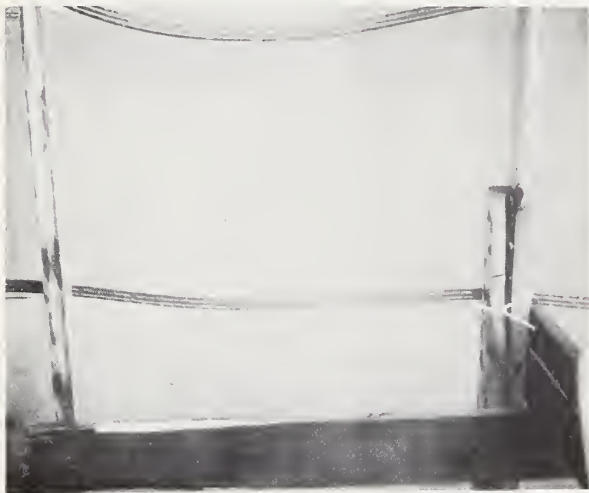
Studies of the water infiltration resistance of four joint configurations were conducted.

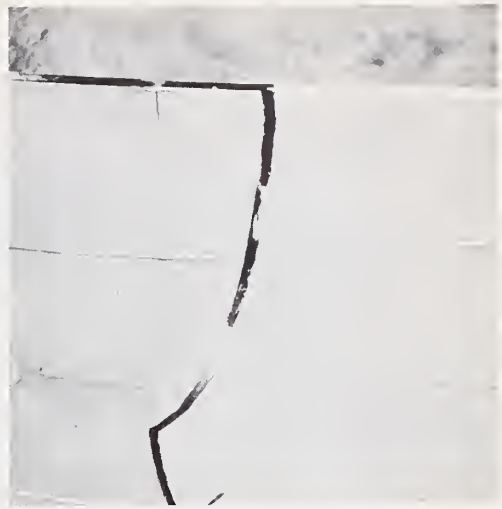
Sufficient water pressure always resulted in leakage at panel joints as shown by dark streaks. Resistance to infiltration was generally equal to the differential height of the joint. The addition of a rail-based caulk increased this resistance by at least 2 inches of hydrostatic pressure.

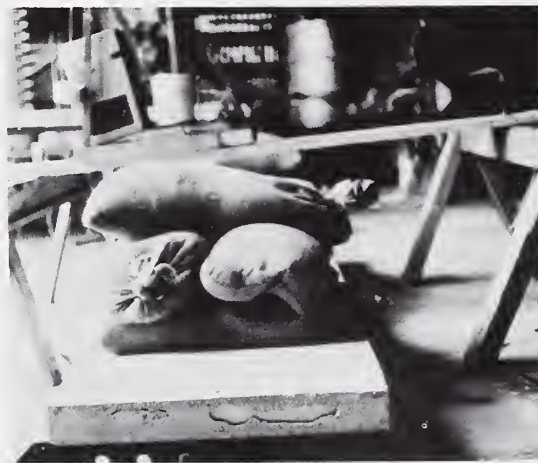
To determine the fire resistance of panels in a wall, a panel was broken. The openings were cut into it and ignited. Although expanded polystyrene is flammable, the fire tended to be self-extinguishing.

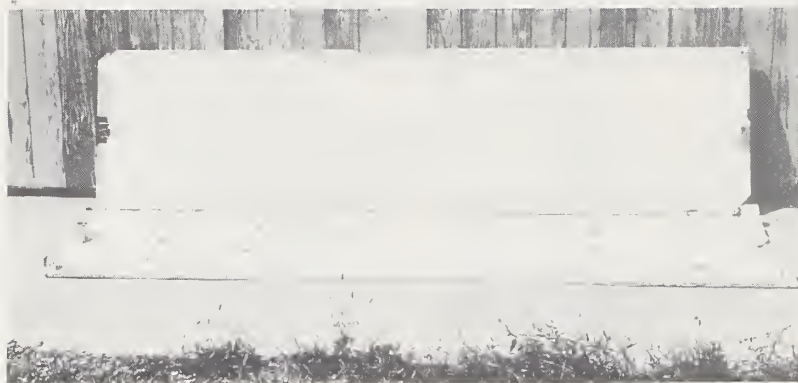
Load tests were conducted on eight representative panels. To simulate a uniform wind load, 50-pound sandbags were applied at quarter points. All panels carried a 42-pound per square foot equivalent uniform load. Some panels carried an equivalent 60-pound load. Deflections were continuously recorded.

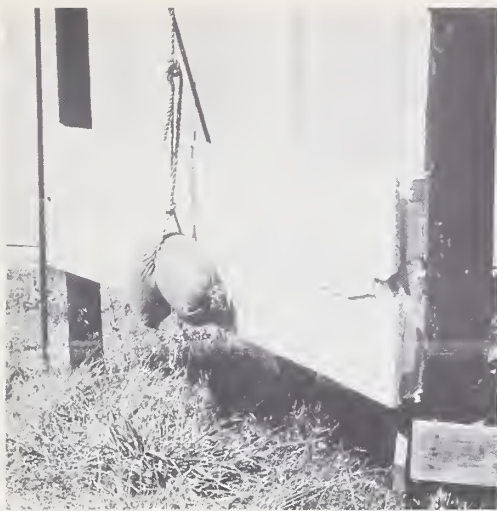
Studies of the resistance to impact were made, because these panels might be subjected to impact from animals, farm equipment, transportation, and erection. A 50-pound sandbag was released from varying heights and permitted to strike the midpoint of the panel.

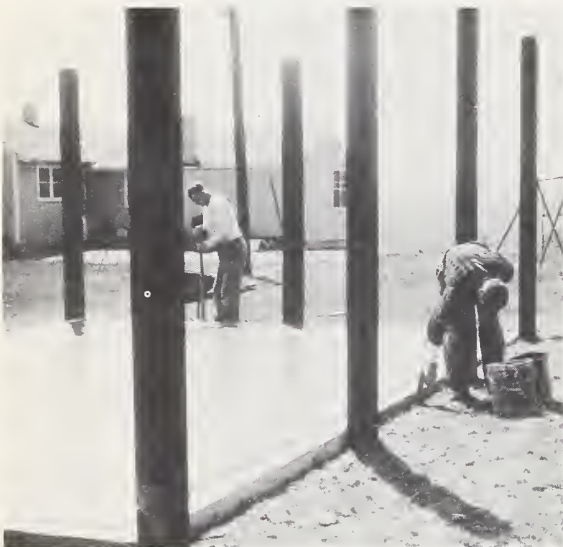
A building of these panels was considered desirable for construction evolution. The structural frame for this building consisted of pressure treated rectangular posts.

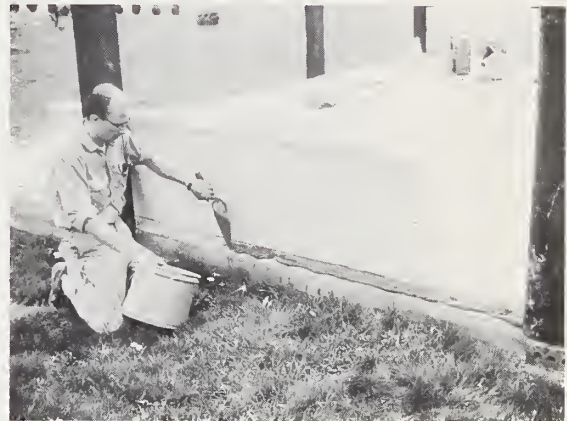
A grade beam from post to post was cast, perimeter insulation placed, and a floor slab cast. Workmen are completing the finishing of the grade beams and floor slab.

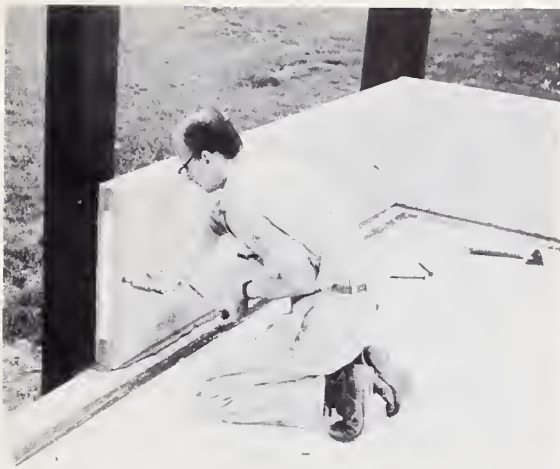
Panels were placed in a bed of mortar as shown. Subsequent panels were joined in this structure by mortar joints.

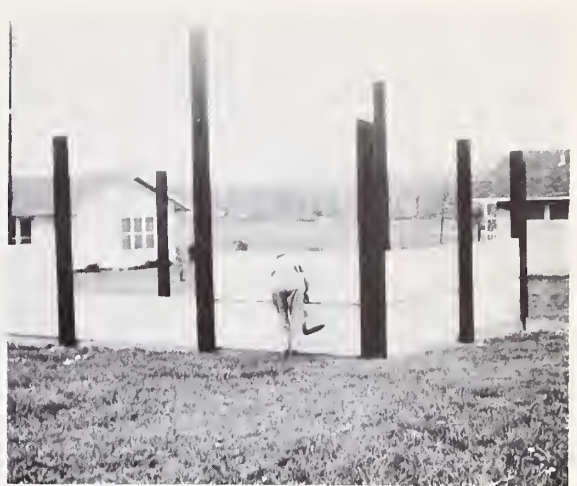
After placing the panel in its mortar bed, a lead hole was bored for a 1/2" x 6" lag screw. Corners were formed by bolting panels to a 2" x 10" that was fastened to the post and by fastening other panels to corner posts with lag screws.

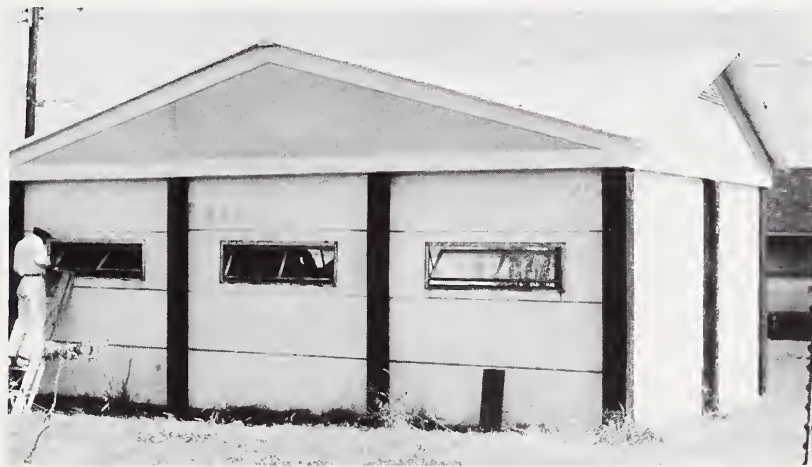
After panels were fastened in place, each joint was tooled. (Further research is in progress on the use of synthetic mortars for horizontal joining.)
